## Removing Carbon From Baking Pans

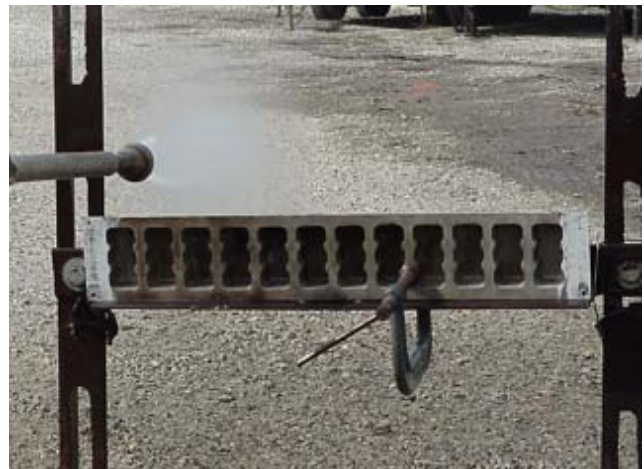
Pan being cleaned with NLB 8400A-2 rotating cleaning lance.

NLB helped the customer solve this problem by using an NLB 4030D pump, which provides 1.5 GPM (5.7 lpm) at 40,000 psi (2,800 bar). The water was applied with an NLB 8400A-2 rotating cleaning lance. This combination cleaned a typical pan in less than a minute.

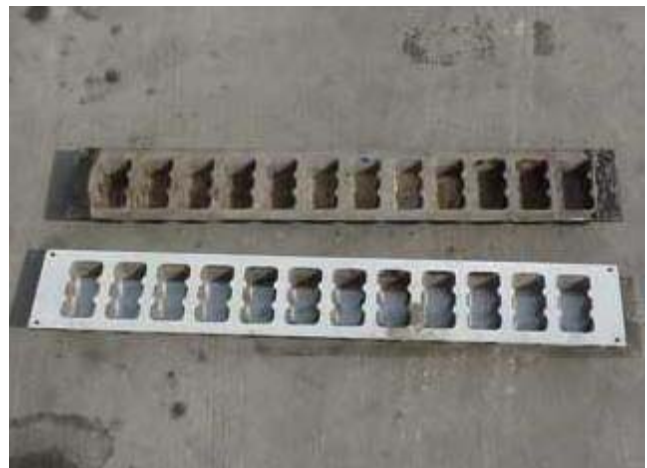
Before and after cleaning.

NLB was recently approached by a customer in the baking industry with a need to clean the baking pans used in production of their products. These pans accumulate carbon build-up from mold release agents oxidizing in the ovens. In this particular application, there was a 3/8 inch thickness of carbon build-up on the pans.
