NLB UHP Water Jets Remove Coatings from Underground Pipes

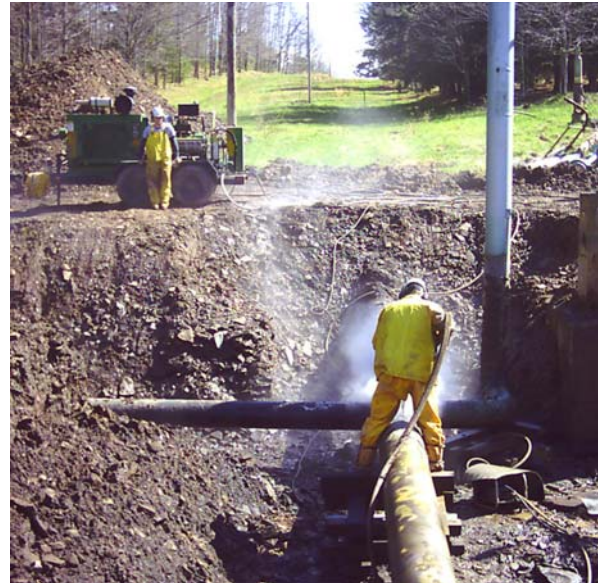
With two operators, the pipe coatings were removed in only one day.

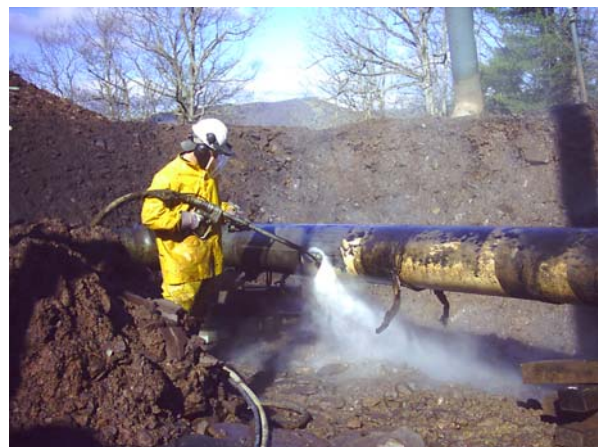
Operator using NLB's NCG8400A-3 Rotating Hand Lance for 100% coating removal.

NLB's ultra-high pressure water jets allowed the contractor to quickly cut through 100% of the coatings, permitting the contractor to immediately prepare the pipe for recoating. The contractor used one NLB 40201D UHP waterjetting pump (6 gpm at 40,000 psi), along with two NCG8400A-3 rotating hand lances. When using two NLB UHP rotating hand lances, powered by a single pump, the two men stripped all of the coatings in just one day. Additionally, by using water instead of grit, disposal costs were minimized and containment costs were avoided.
