### NLB OSB Screen Cleaning System

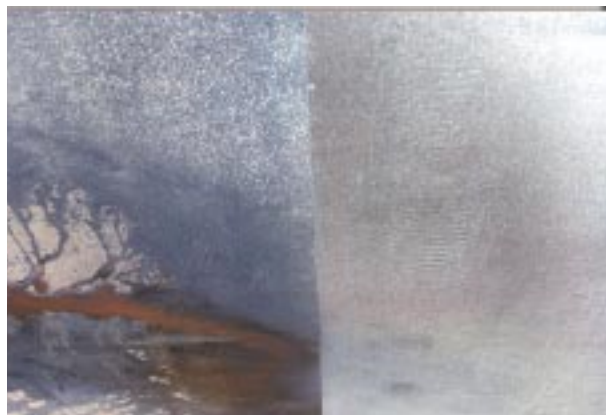
BEFORE

OSB screen before and after cleaning pictured above.

NLB recently developed a new ultra-high pressure screen cleaning system for a leading manufacturer of oriented strand board (OSB). This company has recently experienced some quality issues while producing OSB and tracked the problem back to the screens they use during production. These screens convey the raw materials into the pressing machines and were becoming clogged with debris. This caused gases to be entrapped in the OSB and made the product weak.

The installed system restores the manufacture's screens to a near new condition allowing for increased quality and screen life, along with shorter production times. All these benefits combined to increase profits.
