NLB SPIN-NOZZLE's® Clean Corrosion from Pilings

Madcon Corporation of Ellicott City, MD was contracted to install corrosion-resistant fiberglass jackets on the steel pilings of a pier in Baltimore. The job called for removing all the corrosion and marine life from the pilings to a distance of four feet above and below the mean tide level, since this is where most of the corrosion occurs.

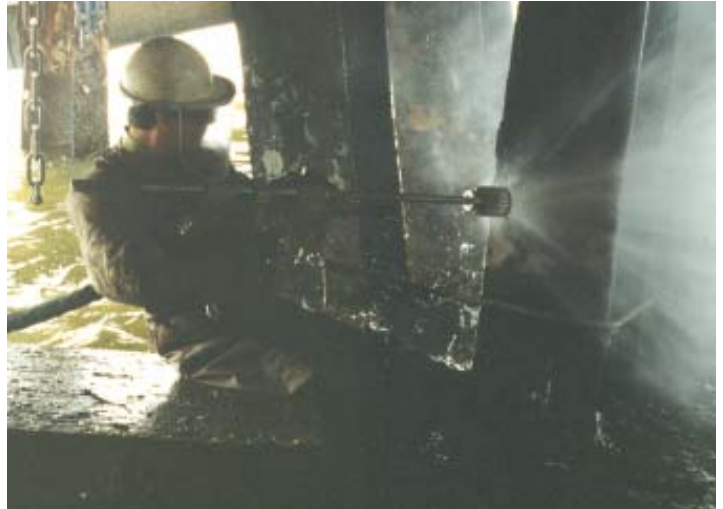
10,000 psi (700 bar) is applied to the pilings with an NLB 10-280 hand lance and a Model SRH 10-77 SPIN-NOZZLE.

After successfully removing the corrosion at 10,000 psi (700 bar) with a flow of 34 gpm (129 lpm), fiberglass cladding was installed and a sealant injected to complete the process.

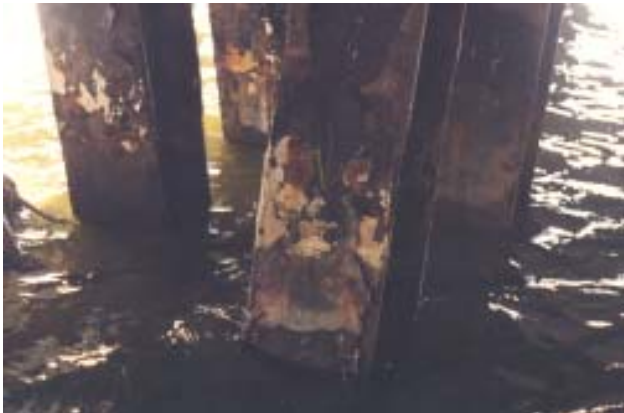
View of the steel pilings prior to application of the high-pressure water.

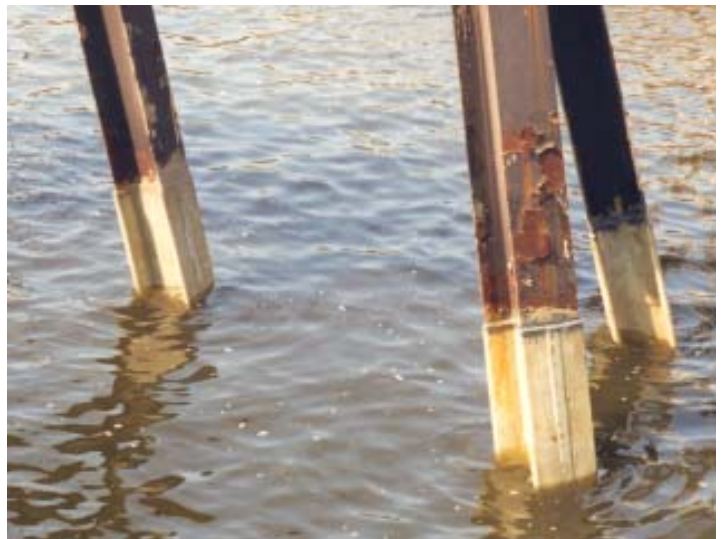
The fiberglass cladding is installed over the prepared surface and extends the life of the steel pilings.
